RE: (Resub) 1st Review Responses to 1-20-00084 SON "Silver Estates"

**SUBJECT: ADDENDUM LETTER #1: CLARIFICATION OF RECOMMENDATIONS AT G4 and G5
SILVER ESTATES THP (1-20-00084 SON)**

Silver Estates Timber Harvest Plan

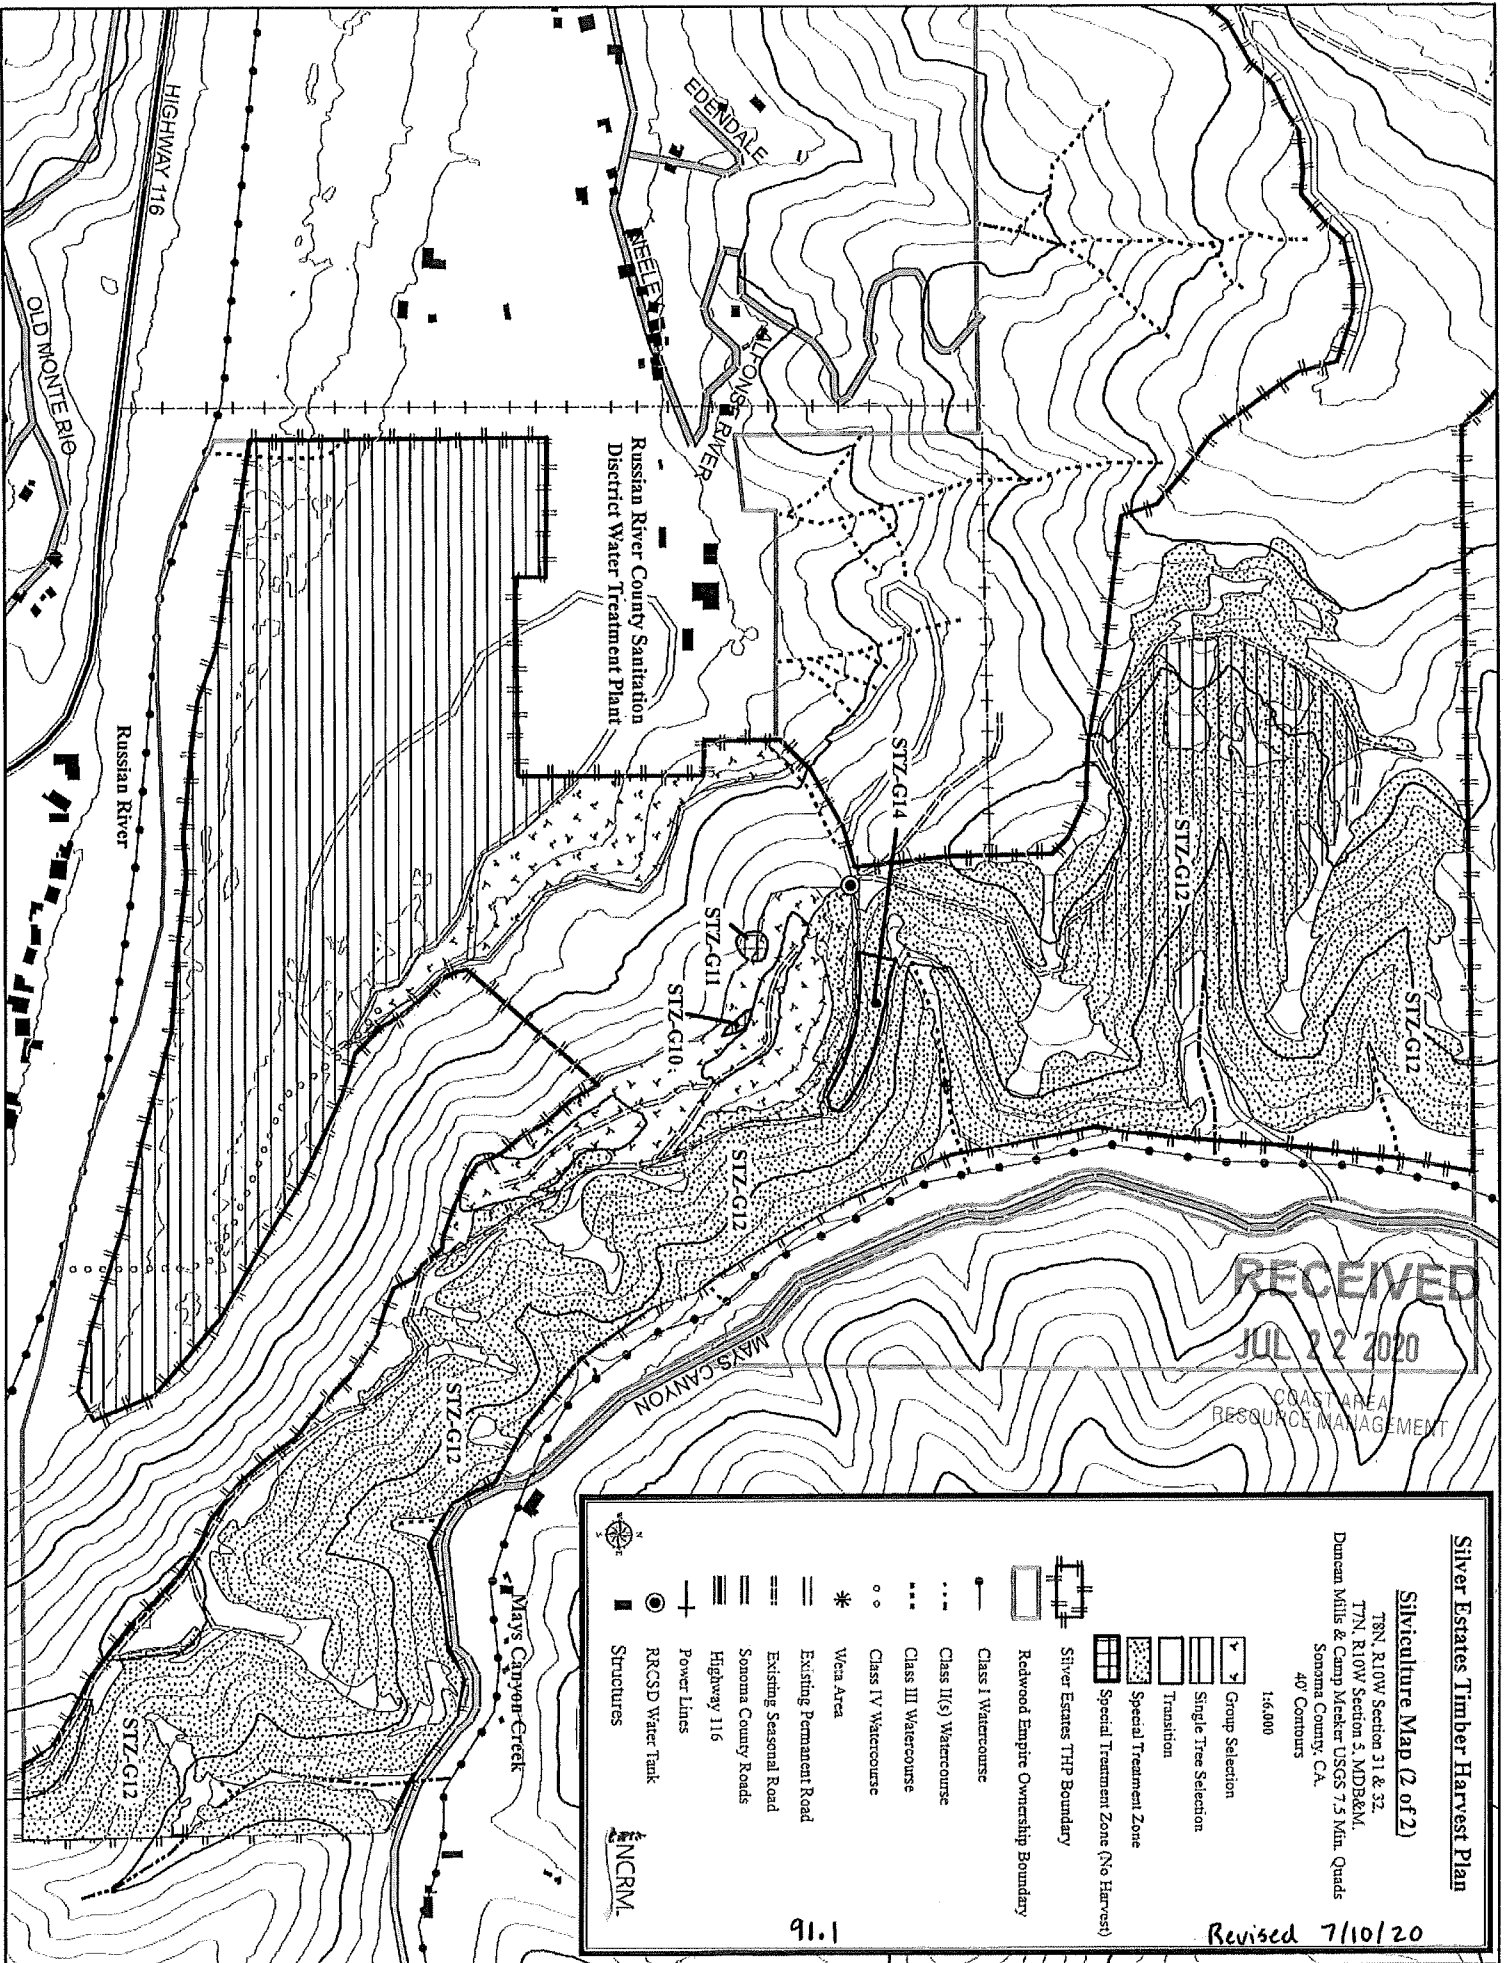
91.1

T8N, R10W, Section 31 & 32,
T7N, R10W, Section 5, NDB&M,
Duncan Mills & Camp Meeker USGS 7.5 Min. Quads
Sonoma County, CA
40' Contours
1:6,000

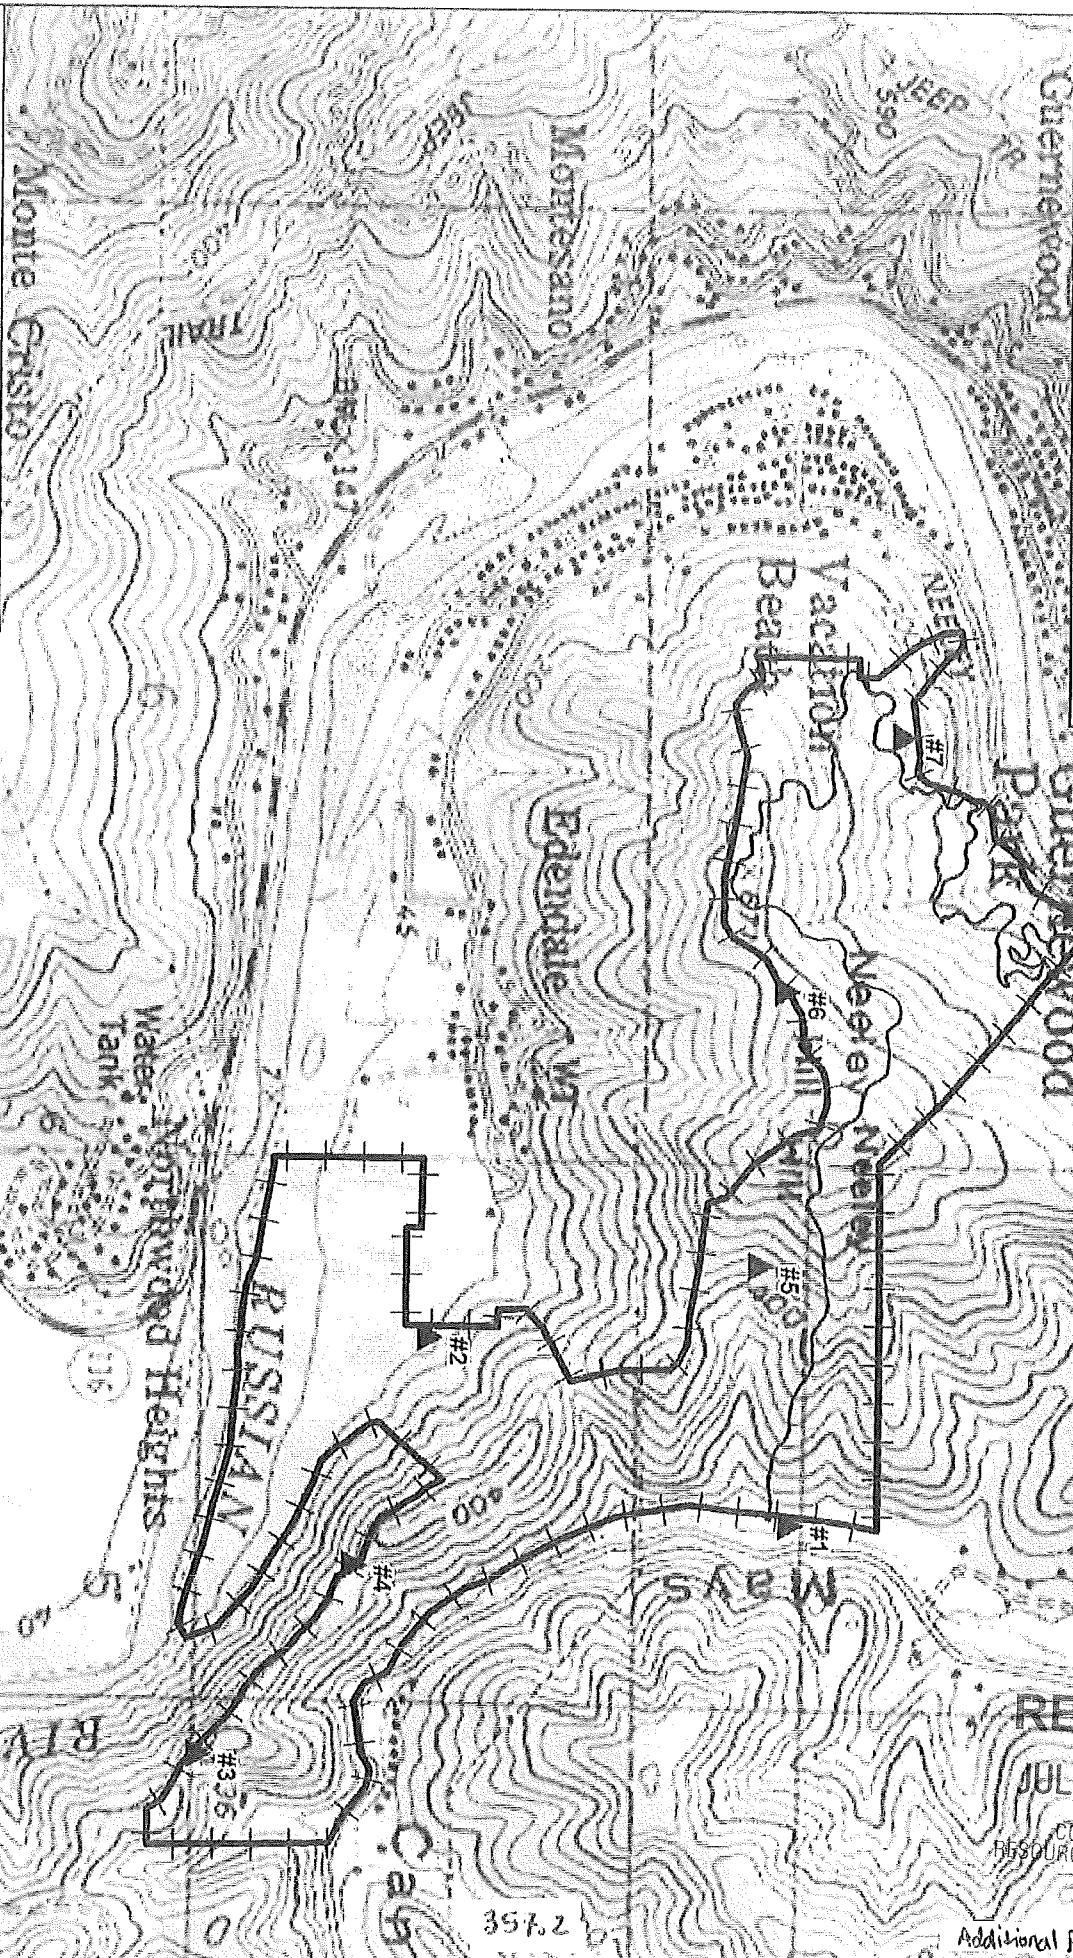
Section 31 & 32 T8N, R10W, MDBM

Duncan Mills & Camp Meeker USGS 7.5 Minute Quads

NSO Survey Stations for the Silver Estates THP
